Reference No. 1314470516-025-L-Rev0

COLLIERY DAMS, NANAIMO BC LOWER DAM – DEVELOPMENT OF DESIGN ALTERNATIVES

This letter report summarizes the findings of studies carried out by Golder Associates Ltd. (Golder) for the City of Nanaimo (City) on the Lower Colliery Dam in Nanaimo BC. These studies, carried out principally in May 2015, were primarily related to further development of flood routing remediation options for the Lower Dam. The remediation options that were to be evaluated were drawn from a list of options identified by the Province of BC, which formed part of the basis of an Order for remediation of the Colliery Dams (BC 2015). This letter report documents additional work that has been carried out on two of the options identified in the Province of BC letter, namely, the Overtopping Option, and the Auxiliary Spillway Option. A general arrangement of the Lower Dam, the existing spillway and the proposed auxiliary spillway location are shown on Figure 1.

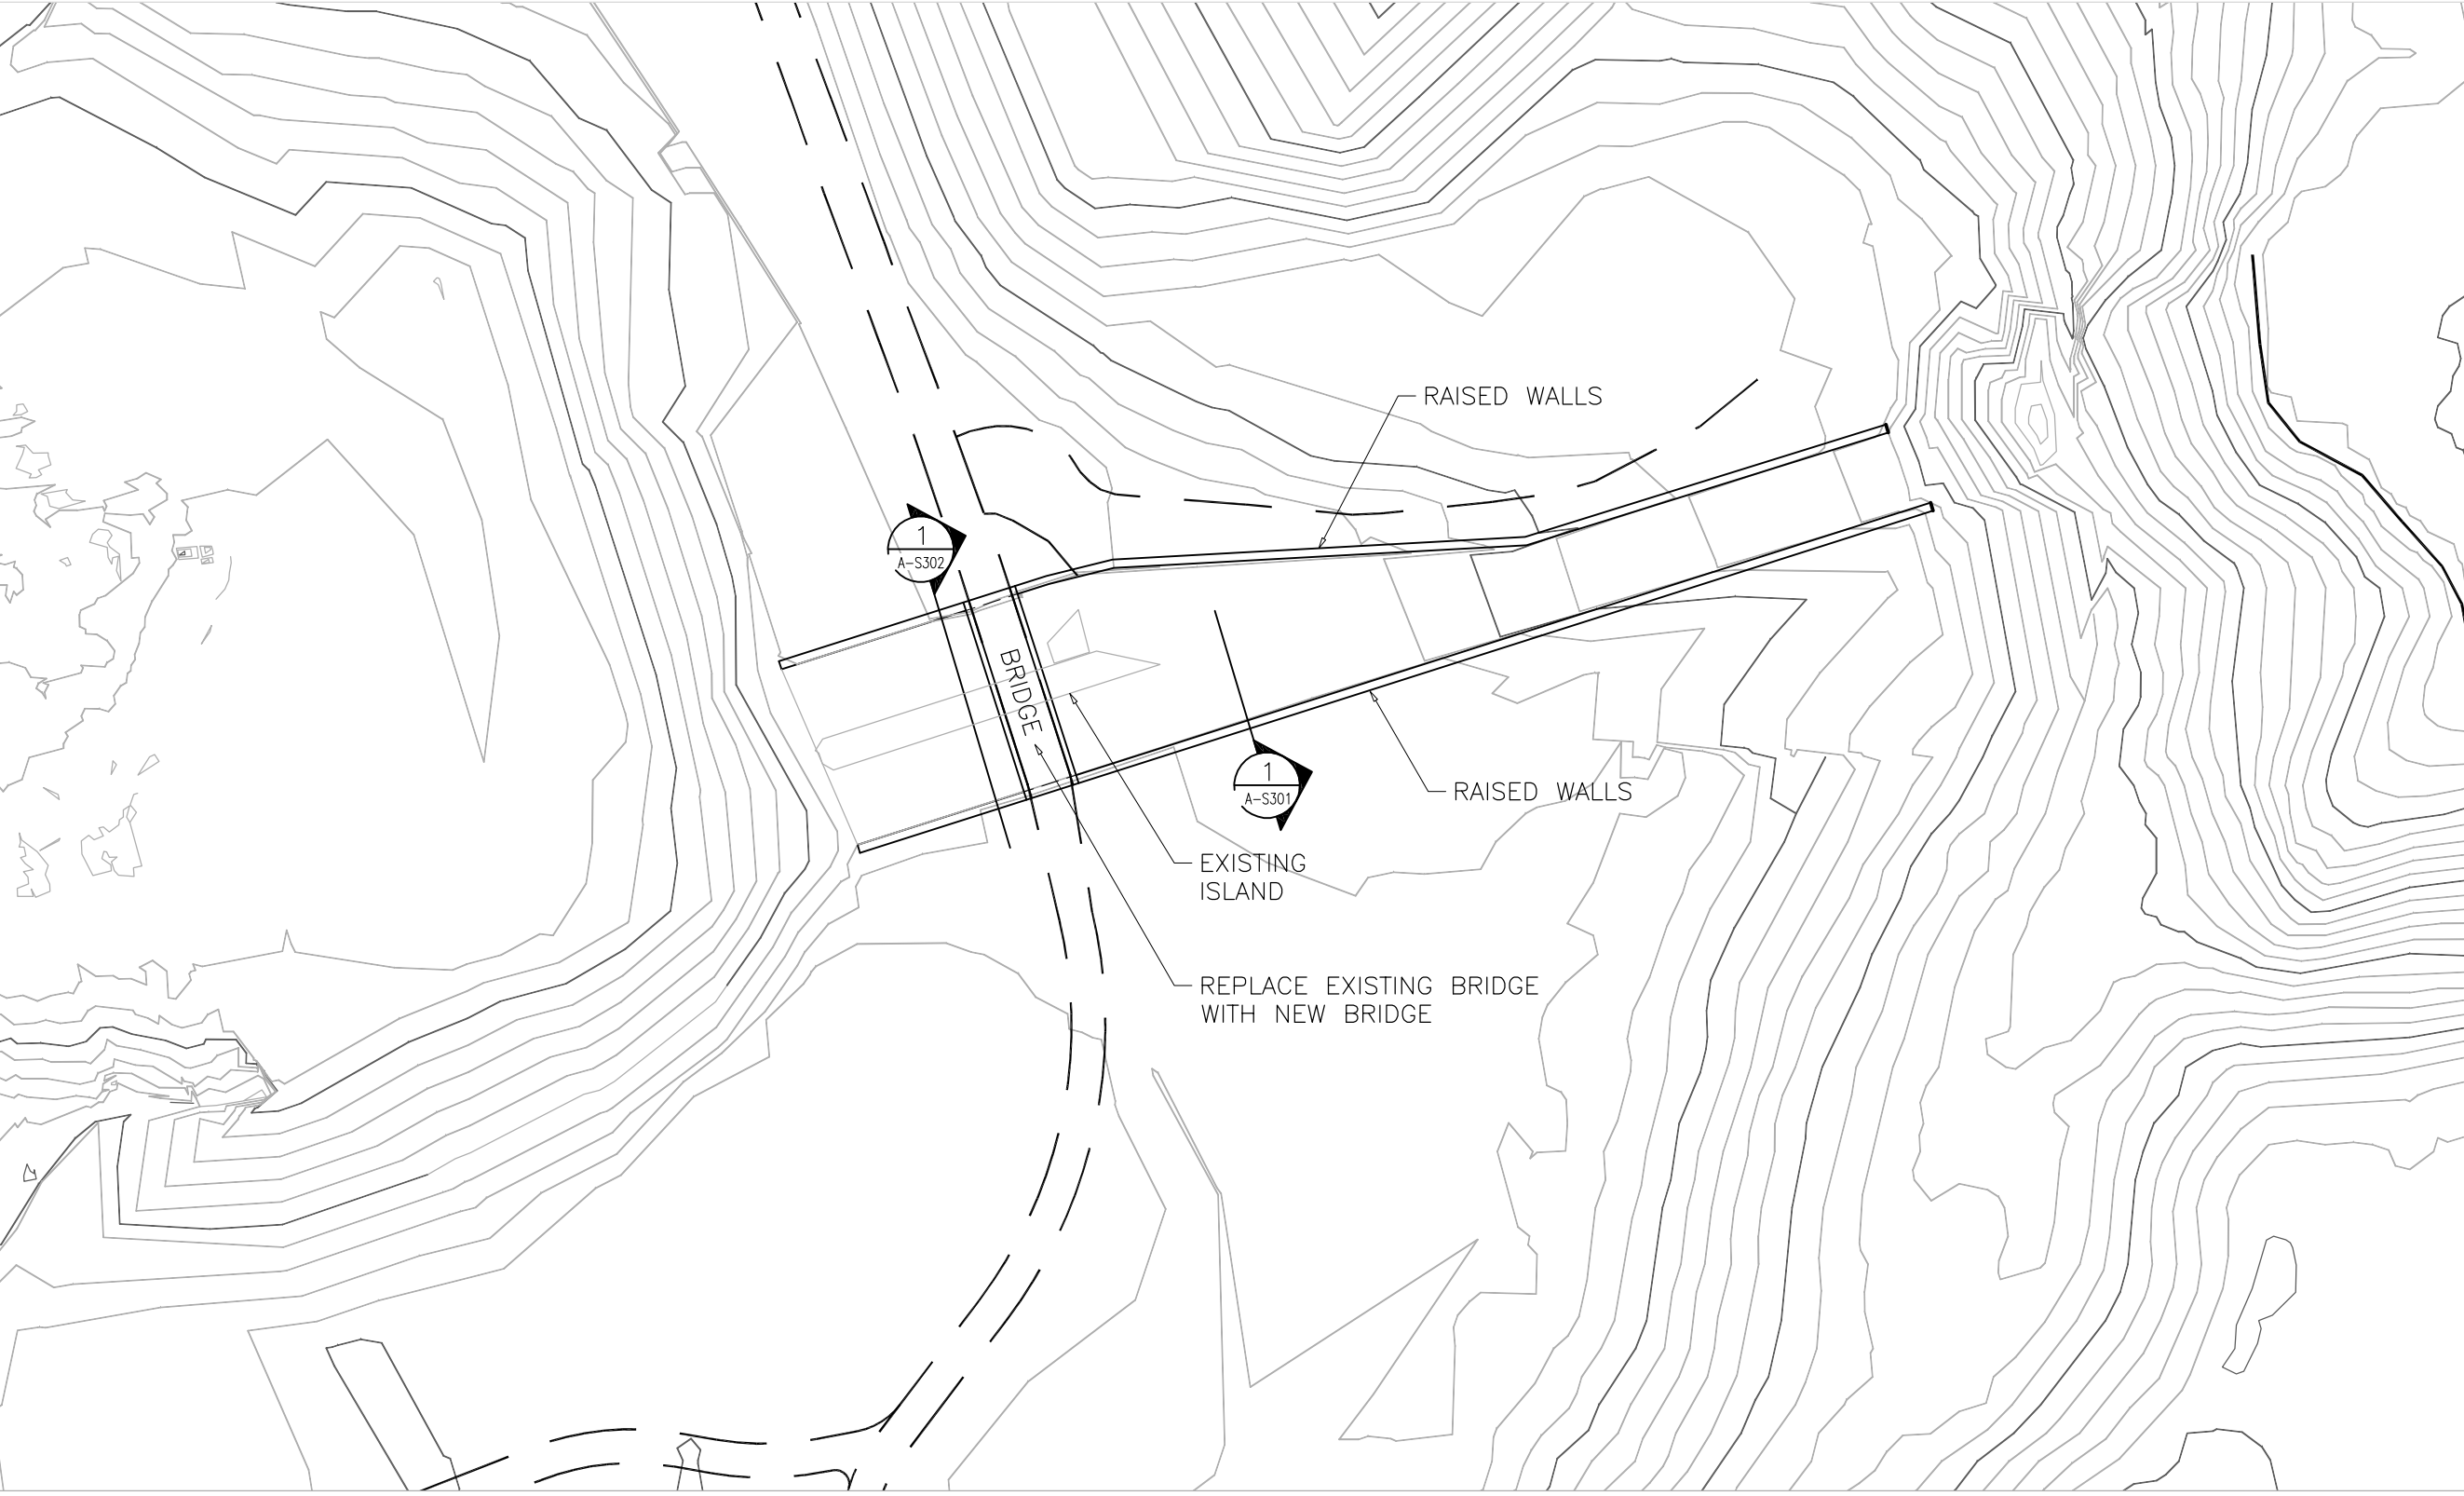
SITE PLAN

**SITE PLAN
 RAISING WALLS OF
 EXISTING SPILLWAY
 AND NEW BRIDGE**

A profile along the spillway walls, together with the required increases to the height of the spillway walls is shown on Figure 3. The structural design for the spillway improvements were provided by Herold Engineering Ltd. (Herold). The structural drawings and corresponding letter report are shown in Appendix A.

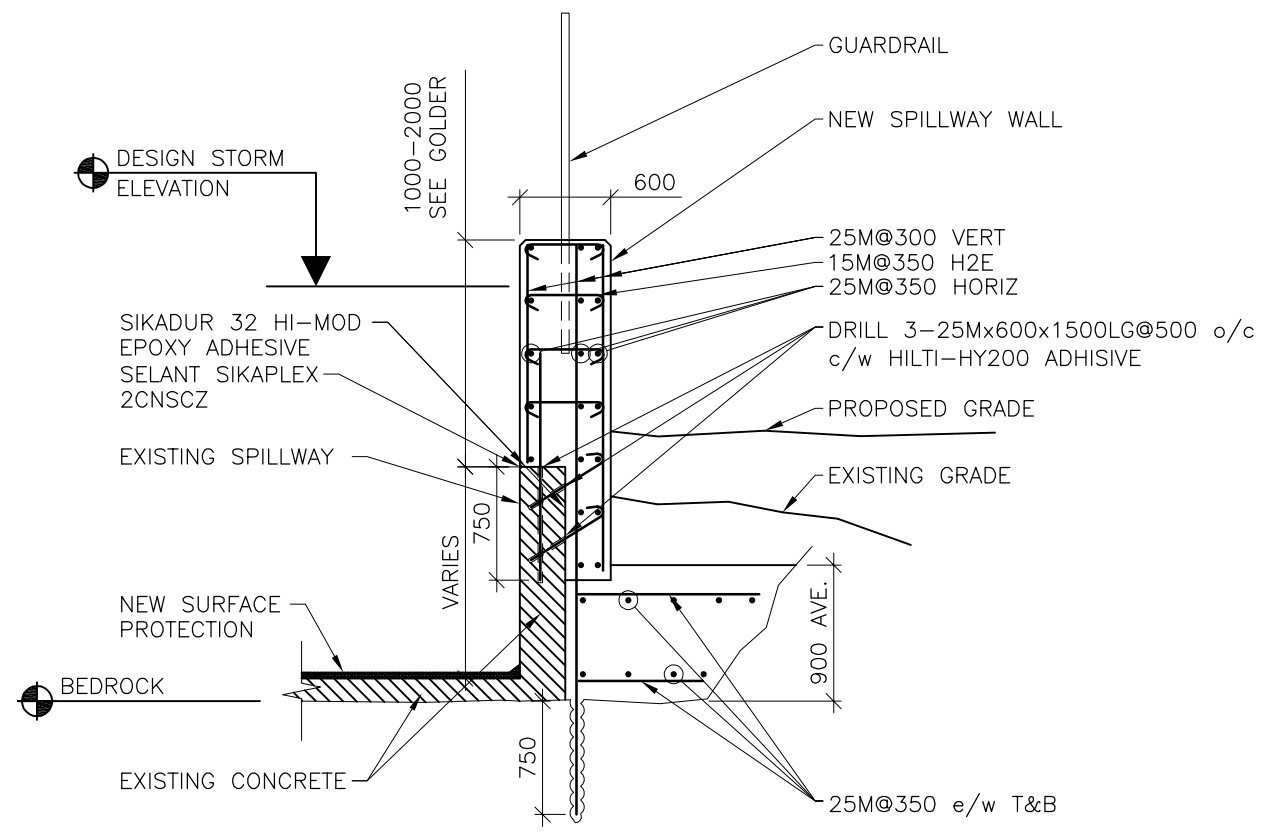
1 SECTION
 A-S200 1:50

READ THIS SKETCH
 WITH GOLDER LOWER
 DAM SPILLWAY WALL
 RAISE PLAN

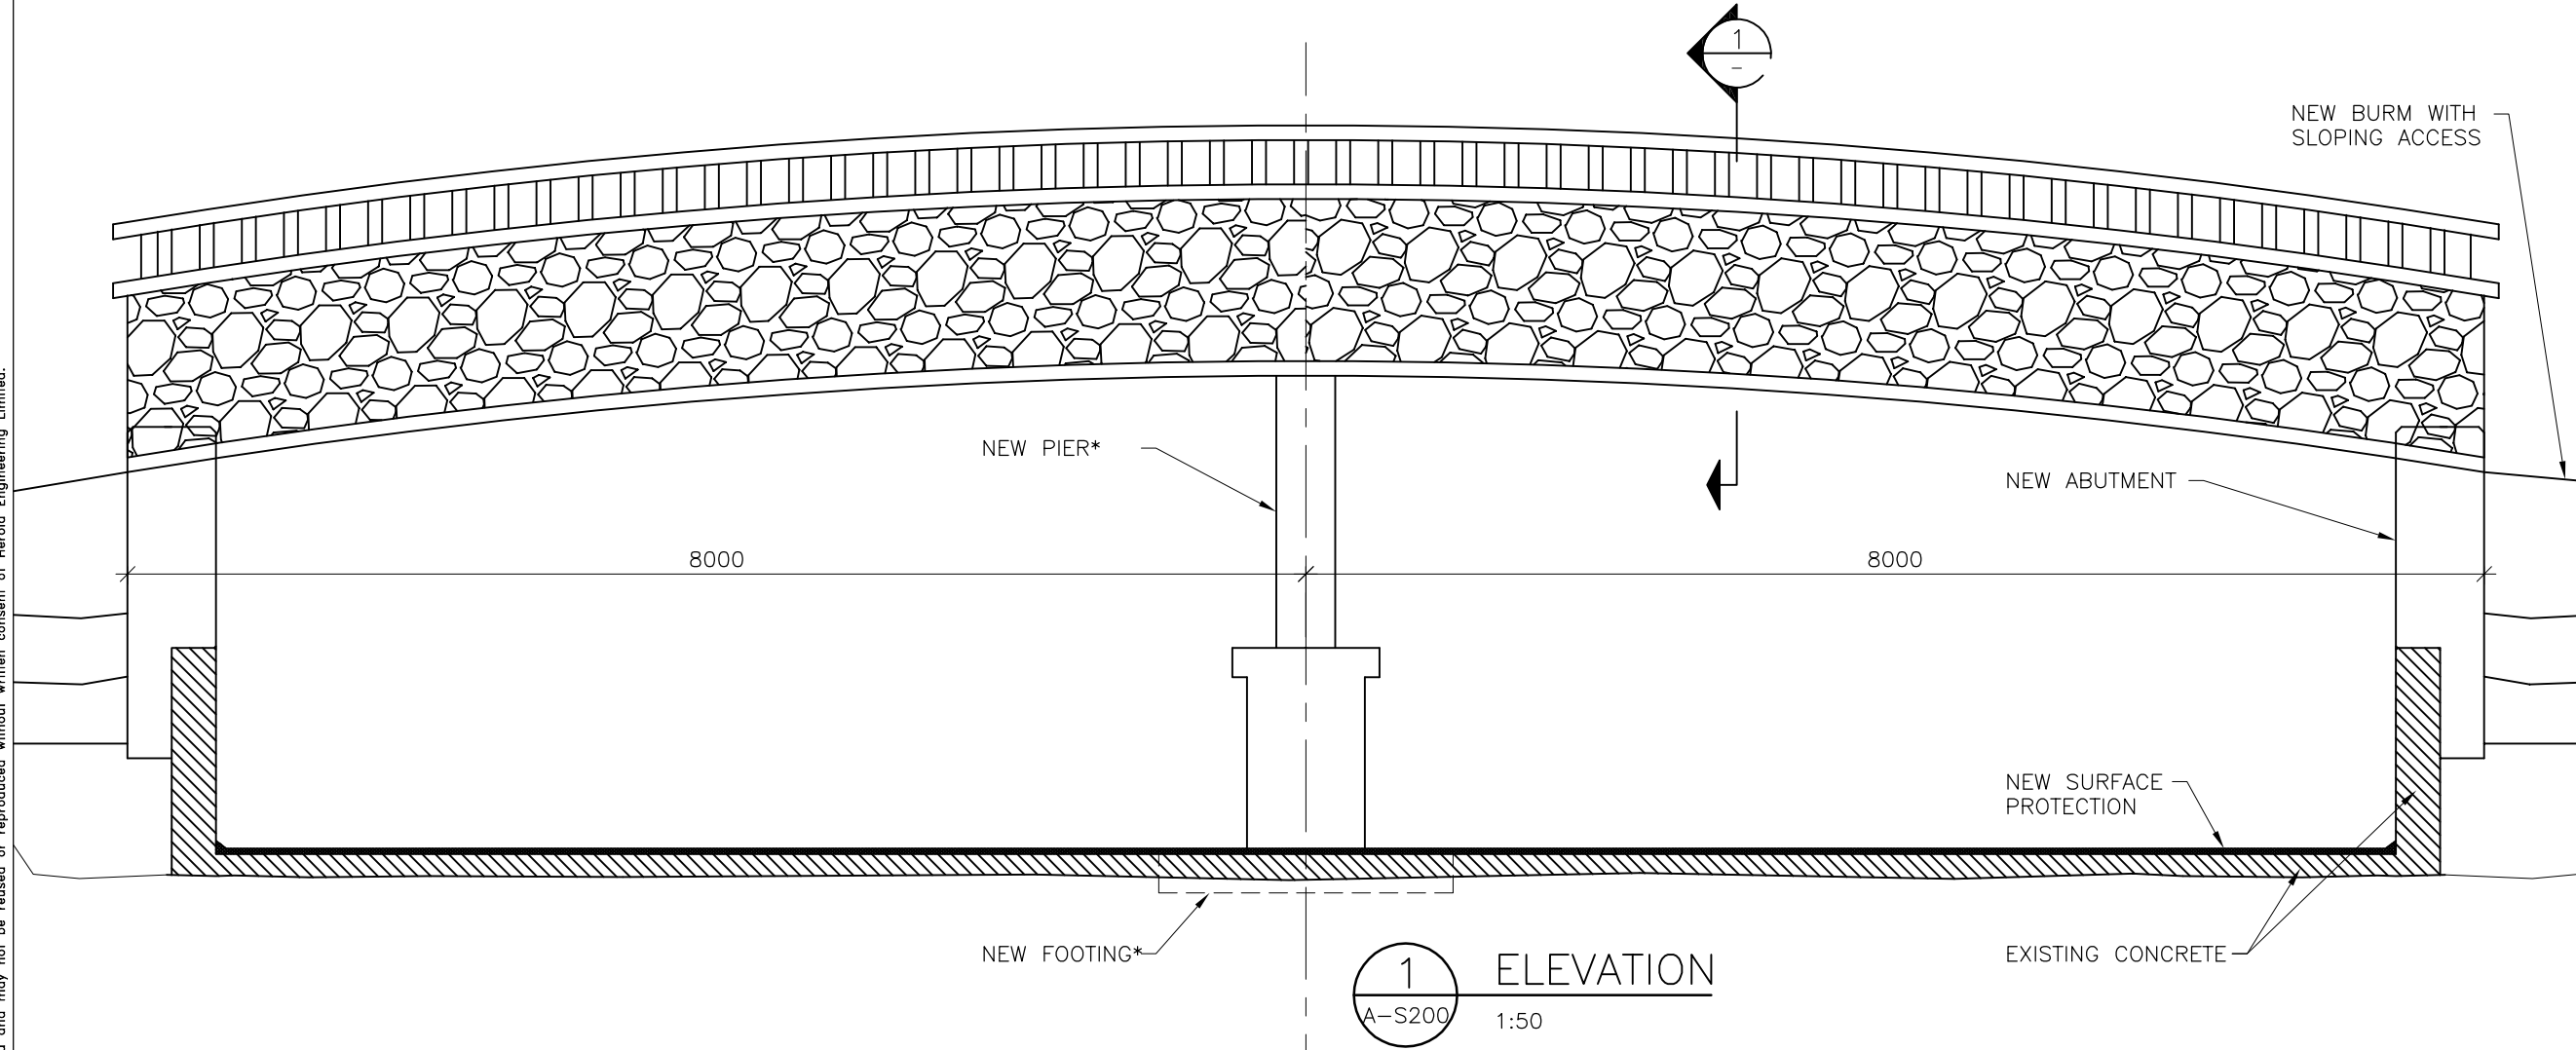
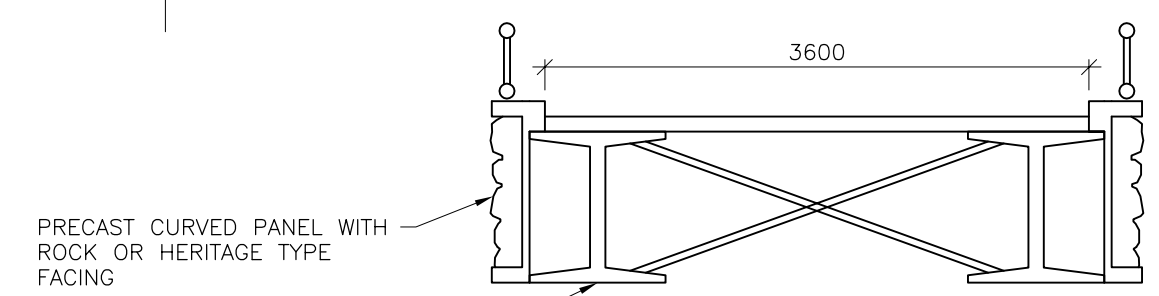
1
 A-S200
 ELEVATION
 1:50

*ALTERNATE IS TO SPAN WITHOUT CENTRE PIER

PRECAST CURVED PANEL WITH ROCK OR HERITAGE TYPE FACING
 1000DP PRE-STRESSED STANDARD I-BEAMS
1
 SECTION
 1:50

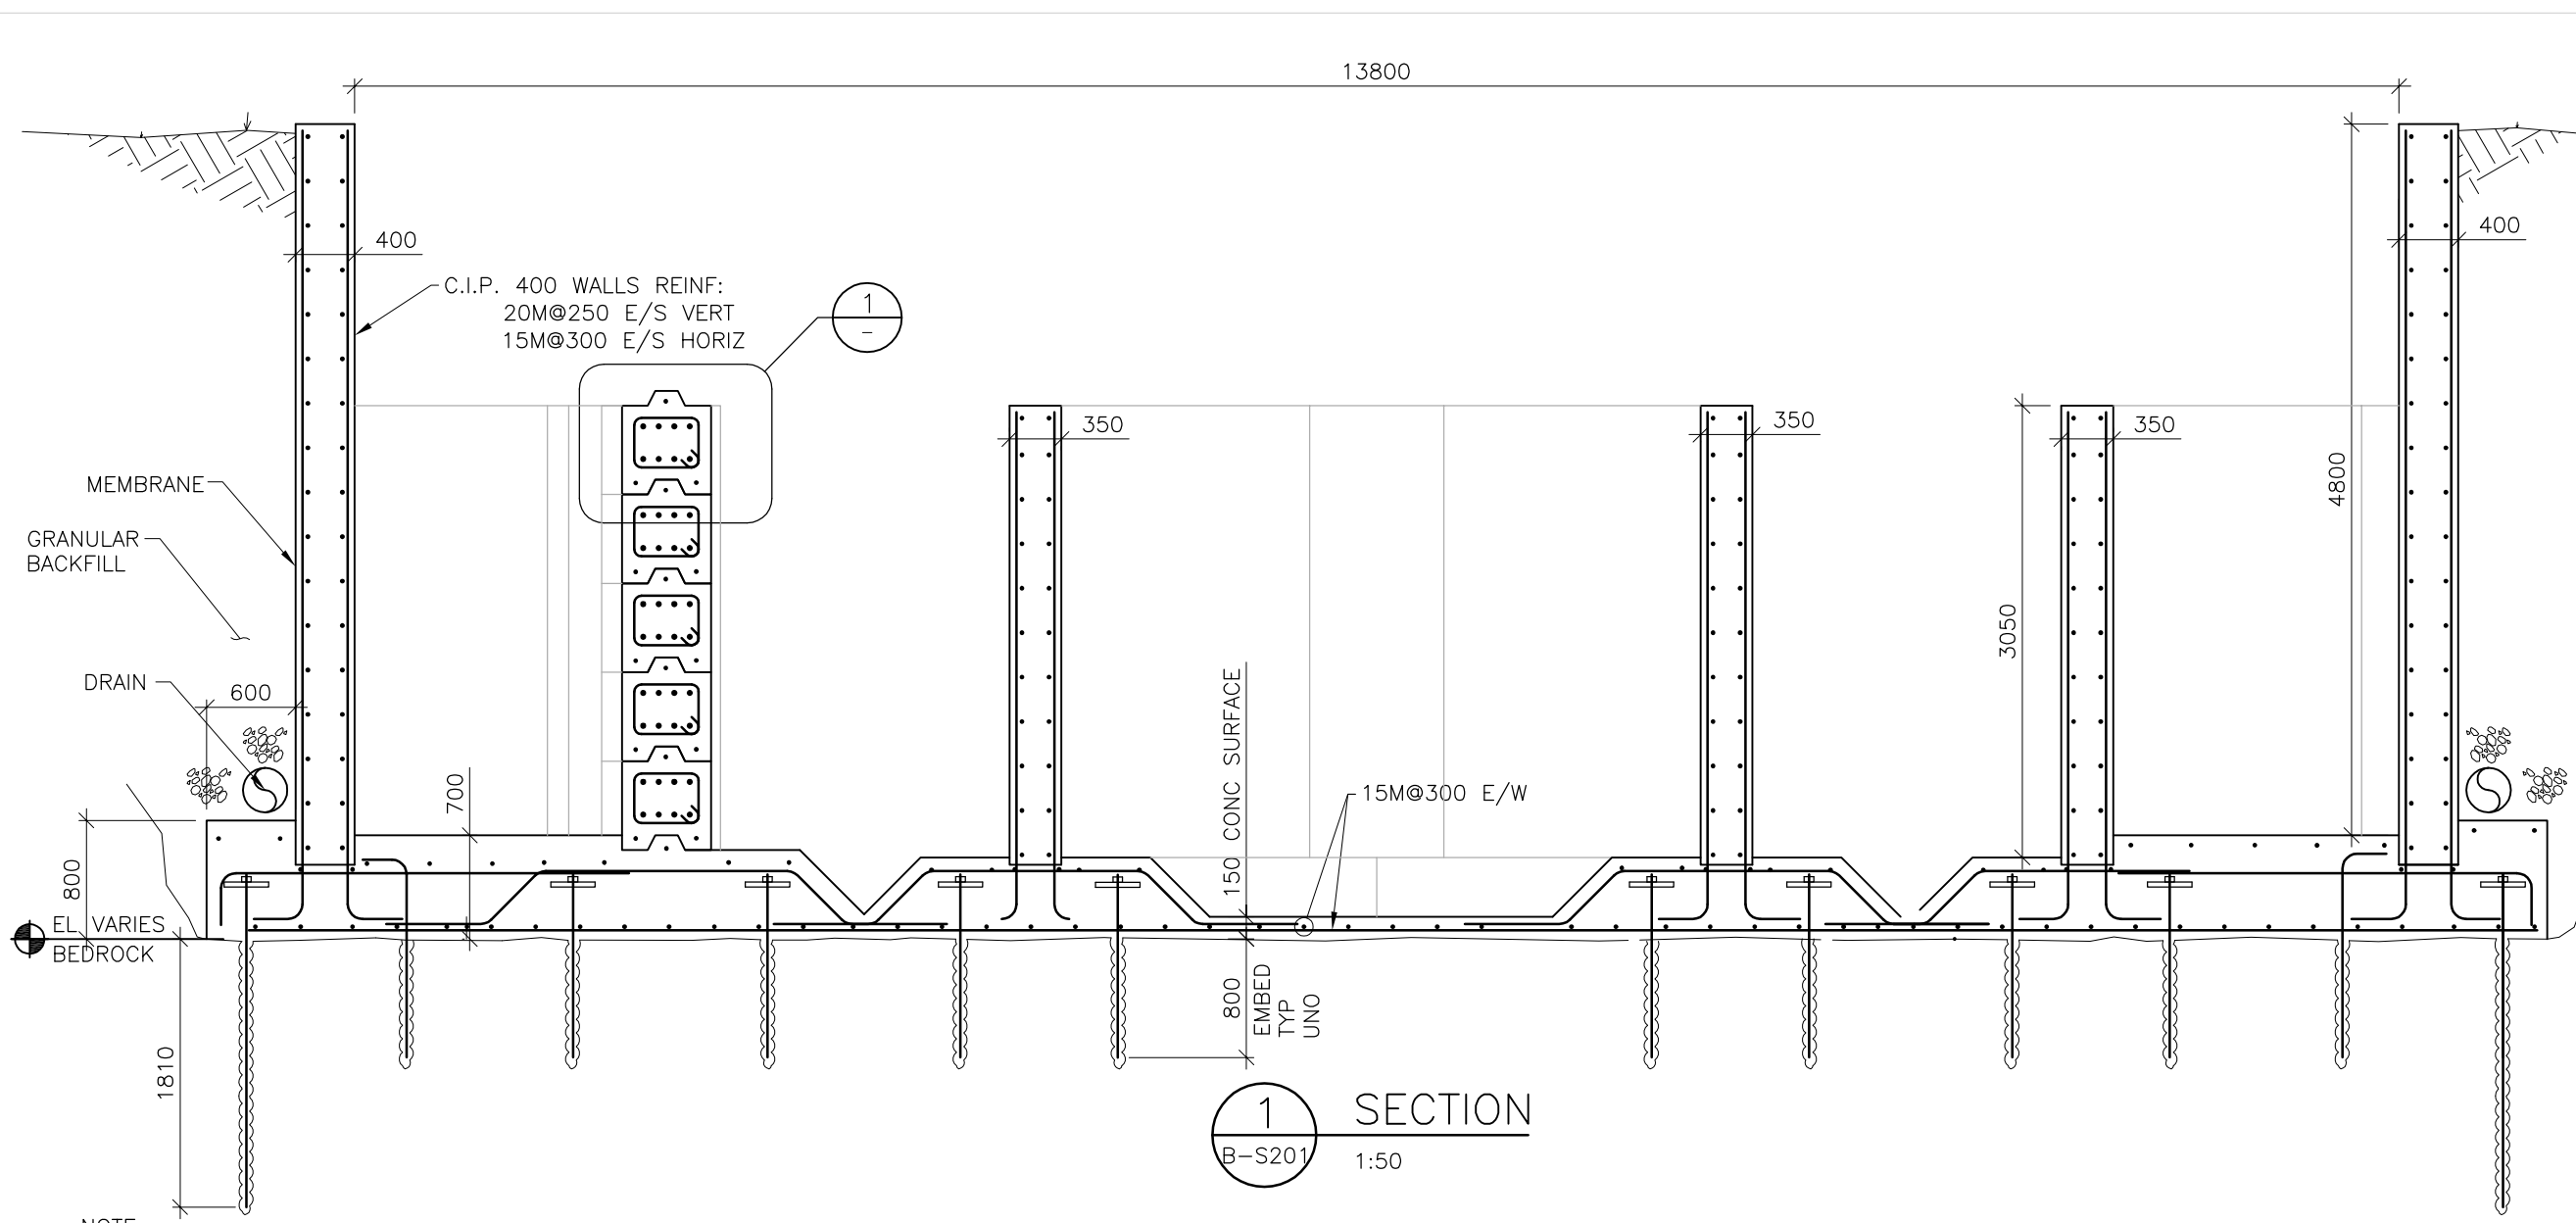
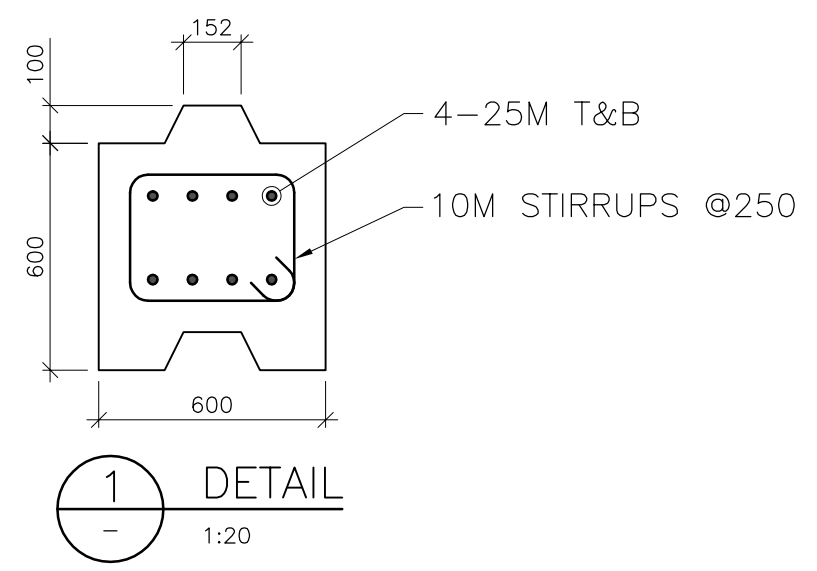
- CONCRETE C.I.P. WALLS : 45MPA
- CONCRETE REMOVABLE LOGS : 45MPA
- CONCRETE SLAB ON BEDROCK : 45MPA c/w WEARING SURFACE
- CONCRETE SUSPENDED SLAB : 30MPA REFER TO PLAN FOR THICKNESS AND REINFORCEMENT

AUXILIARY SPILLWAY SECTION THROUGH LABYRINTH	
DRAFTED BOG	DESIGNED
DRAFTING REVIEW	DESIGN REVIEW
PROJECT No. 0017-276	CLIENT DRAWING No. n/a
SCALE AS SHOWN	PERMIT No. n/a
HEL DRAWING No. B-S301	REVISION A

Preliminary structural designs for the labyrinth weir and box culverts are presented in Appendix A of this letter report. As indicated previously, it has been assumed that these structures will be founded on bedrock. A cast-in-place box culvert design has been adopted, rather than a pre-cast box culvert option (or bridge option), as this will reduce the size of equipment needed for the project (a large crane would be required to transport and place the heavy pre-cast box culvert sections).

5. labyrinth weir construction:
 - a. foundation preparation (suitable rock assumed at base); and
 - b. forming, pouring and stripping of concrete walls.

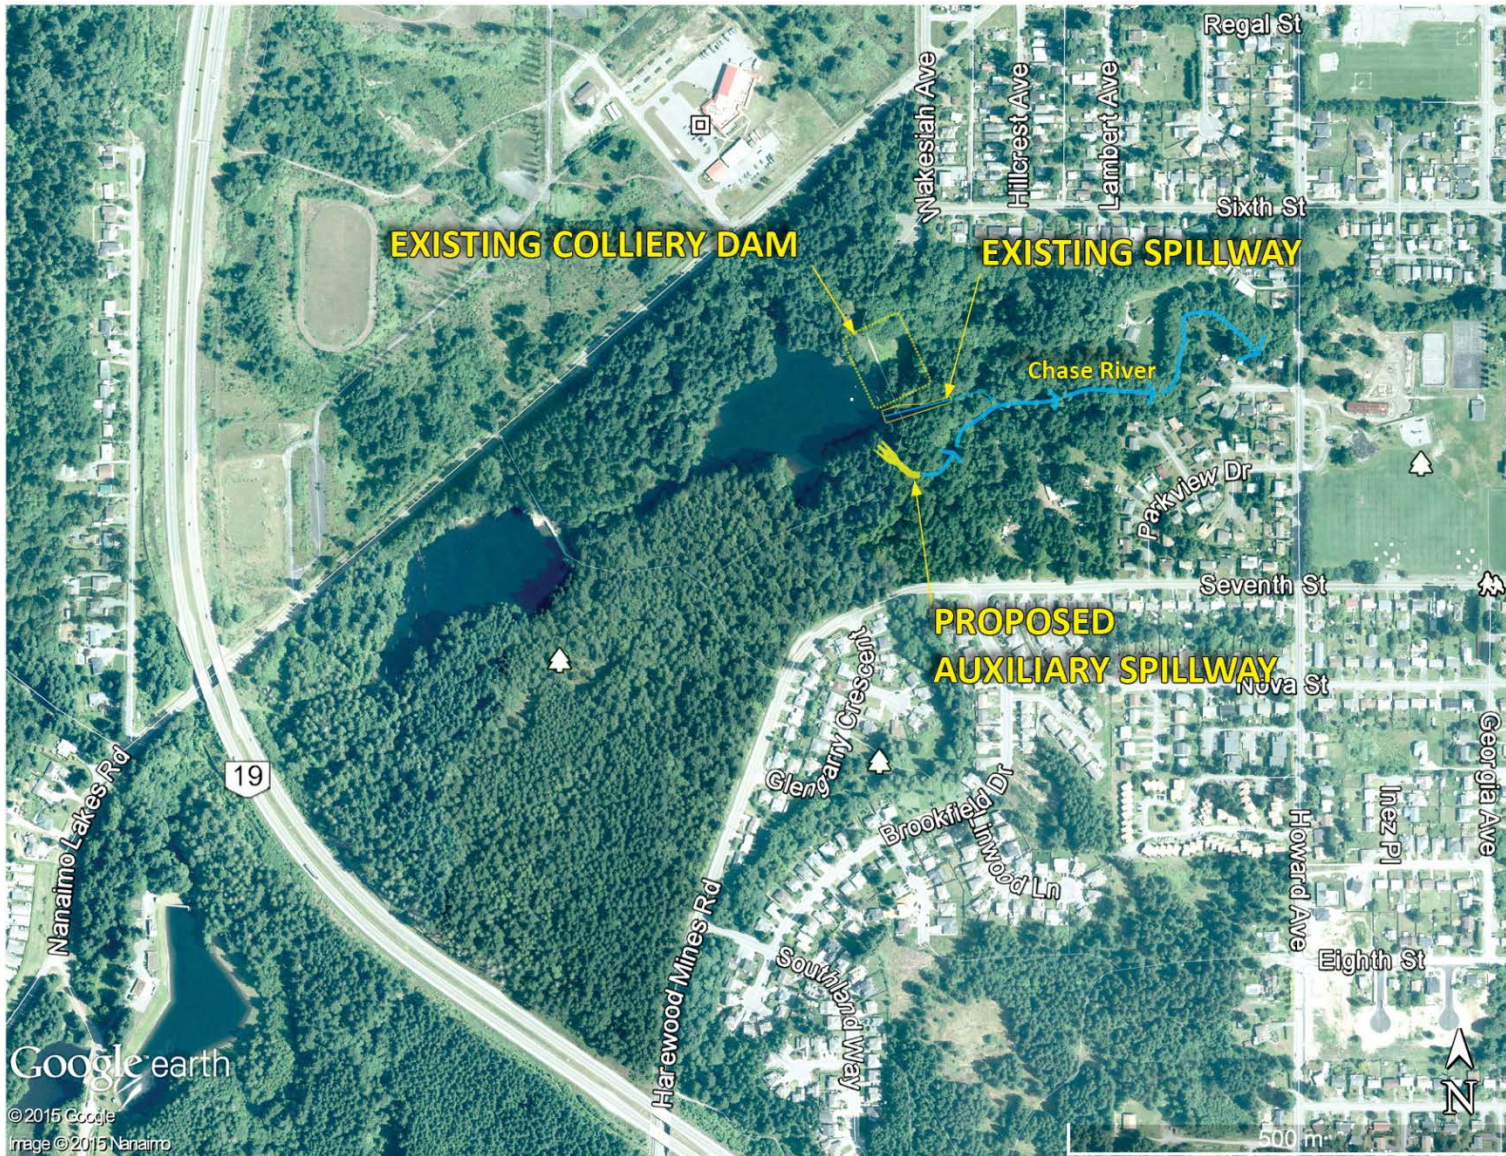
PROJECT		Colliery Dams Nanaimo, BC			
TITLE		Auxiliary Spillway to Harewood Creek Context Plan

APPENDIX D
Visualizations of Auxiliary Spillway Design Concepts

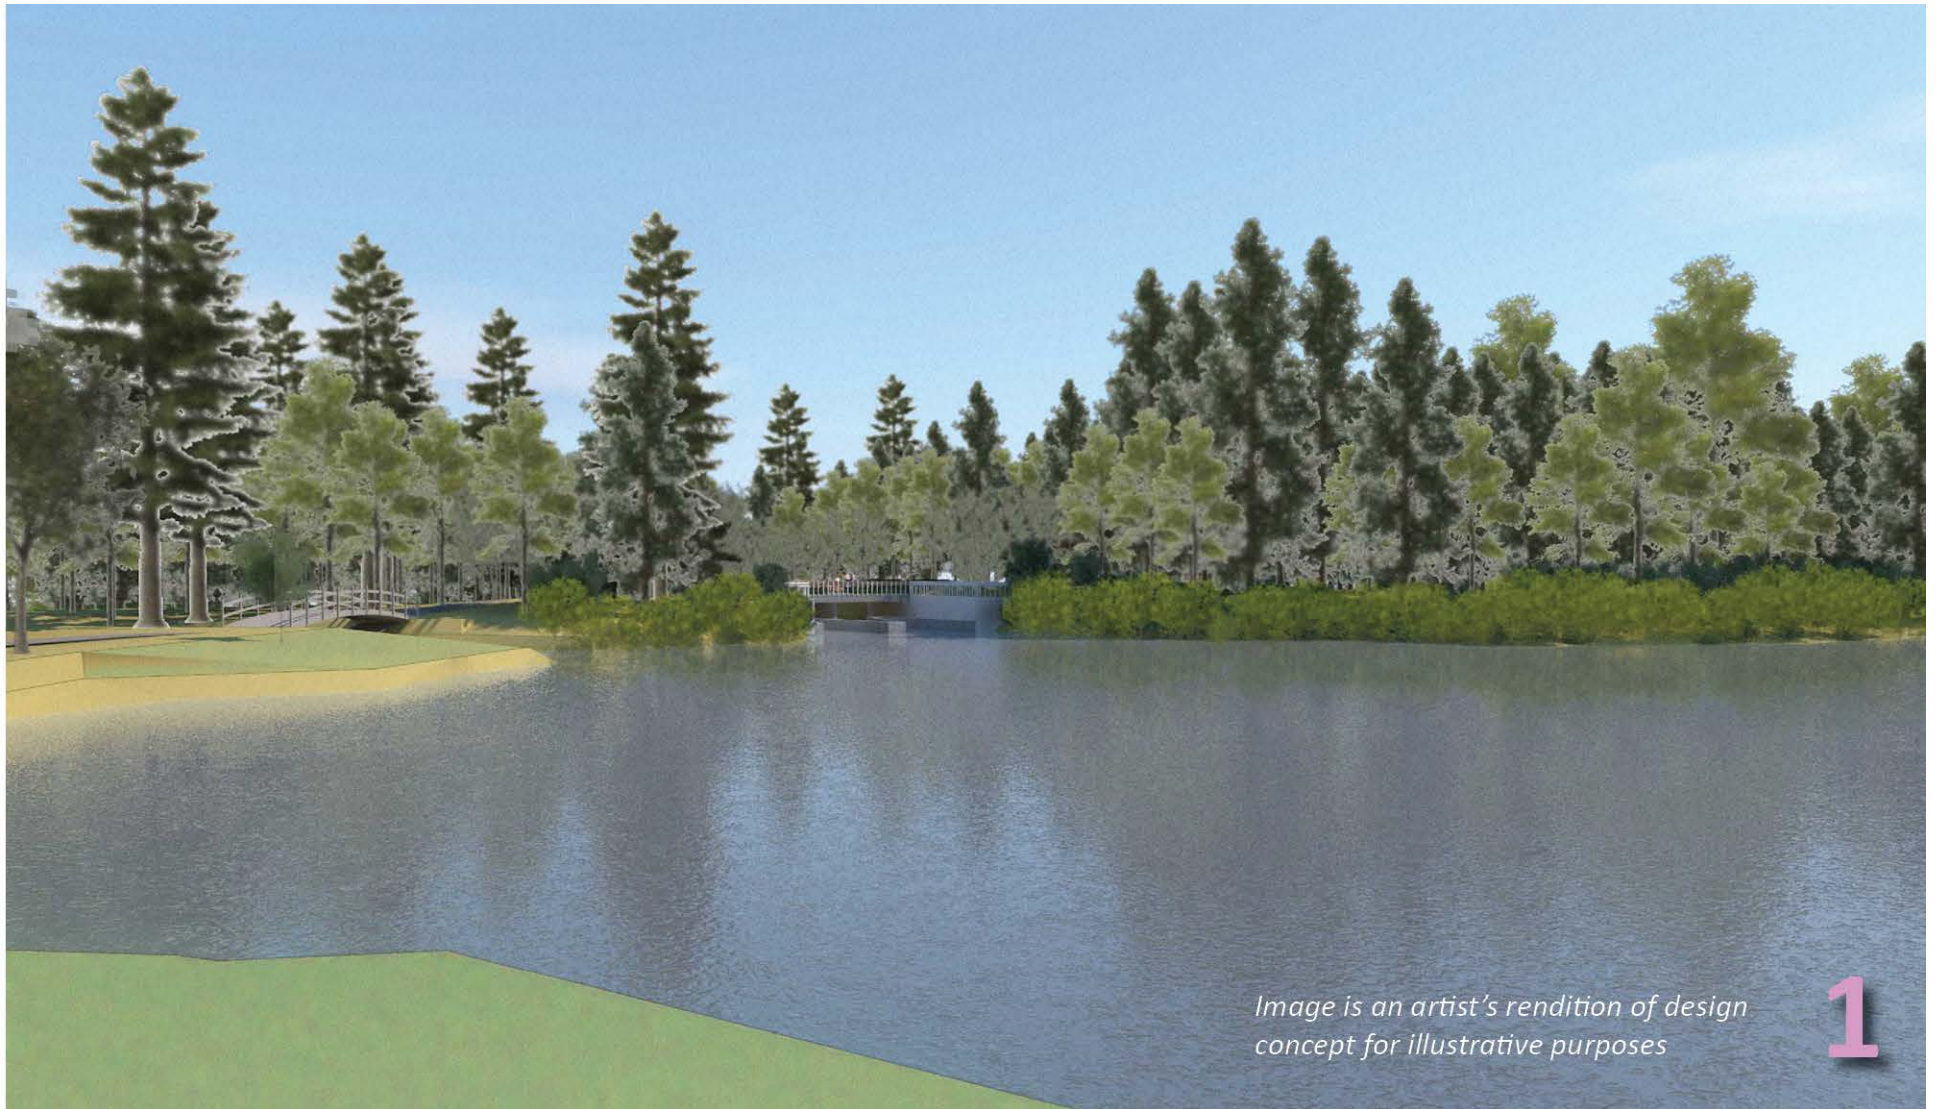
PROJECT No.	1314470516	PHASE No.	3000
	DESIGN	DC	24 June 15	SCALE: NTS
	CADD	----	----	REV.
	CHECK	JG	25 June 15	Figure D-2
	REVIEW	BD	03 July 15

Image is an artist's rendition of design concept for illustrative purposes

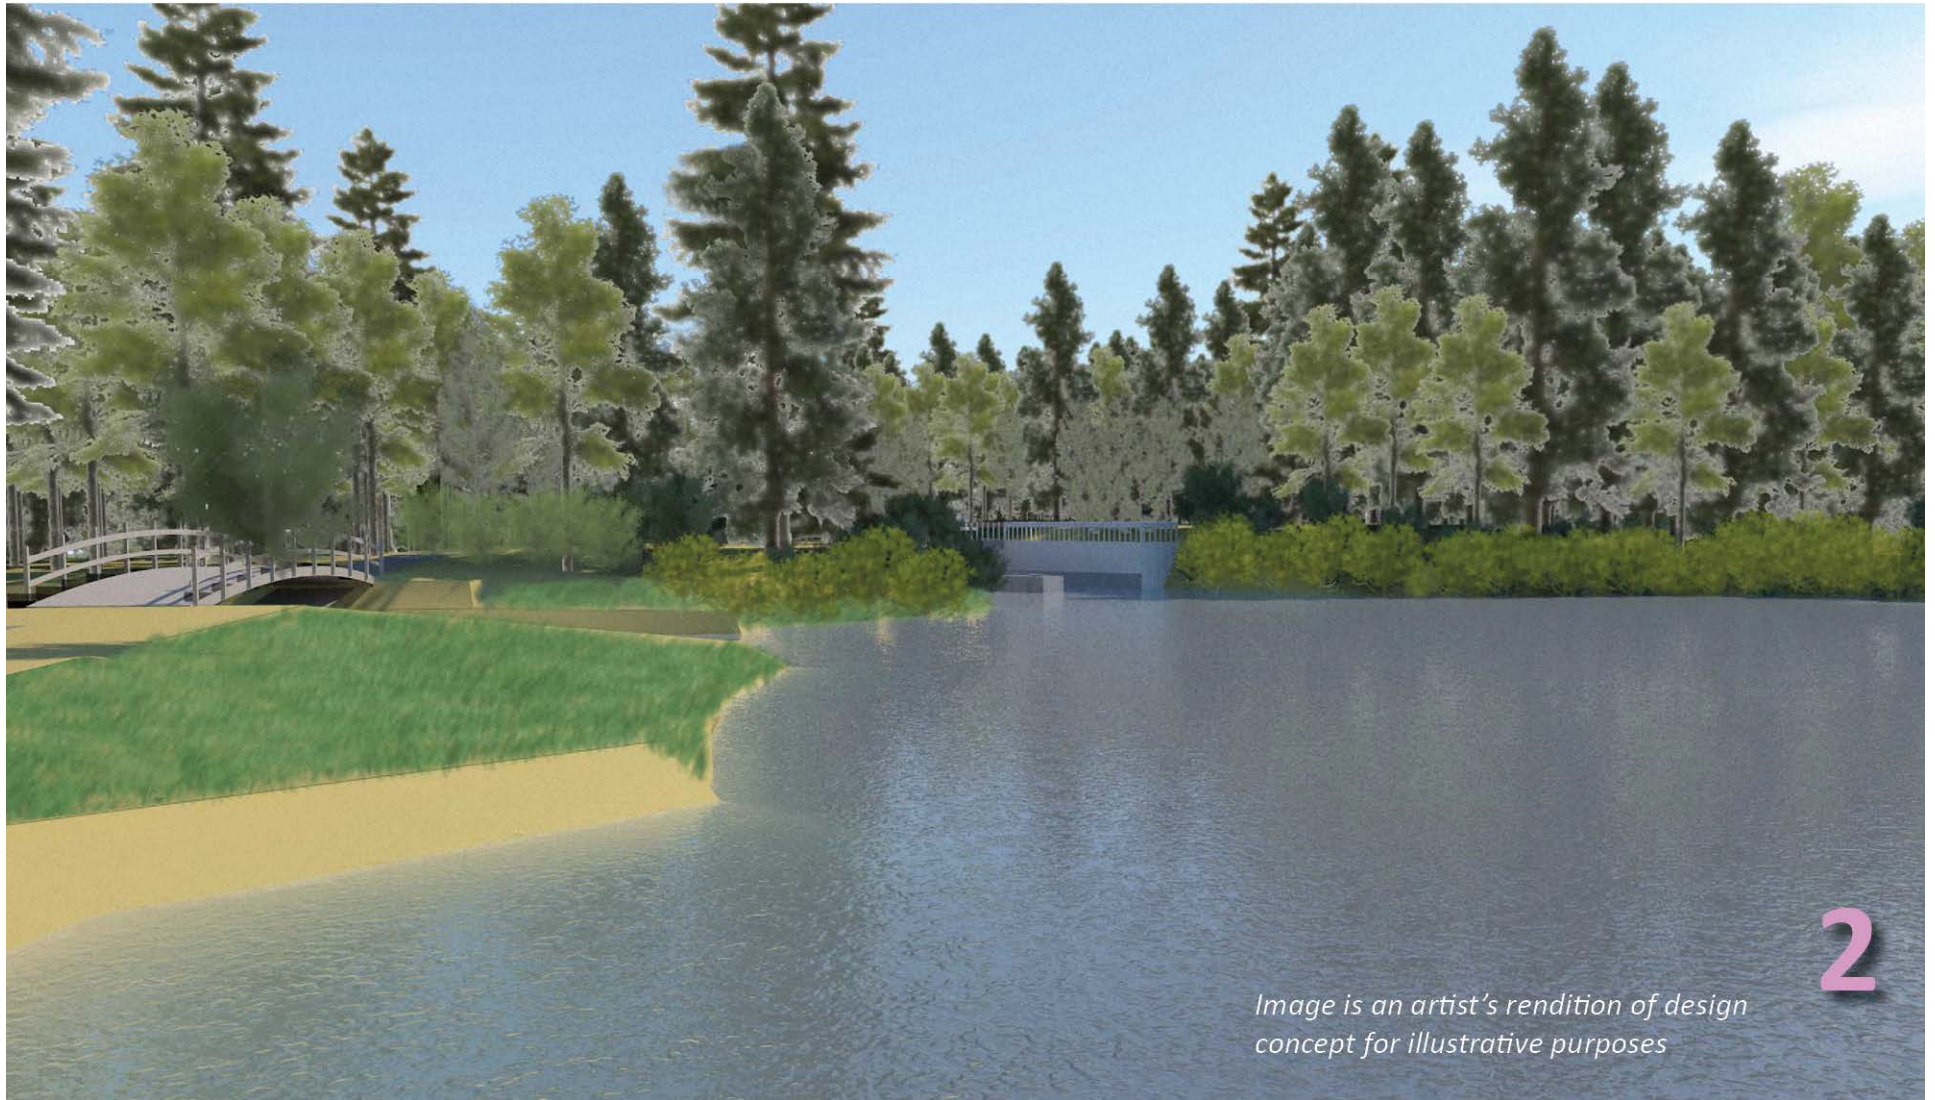
PROJECT No.	1314470516	PHASE No.	3000	
		DESIGN	DC	24 June 15	SCALE: NTS	REV.
		CADD	----	----	Figure D-3	
		CHECK	JG	25 June 15		
REVIEW	BD	03 July 15

Image is an artist's rendition of design concept for illustrative purposes

View from the lake

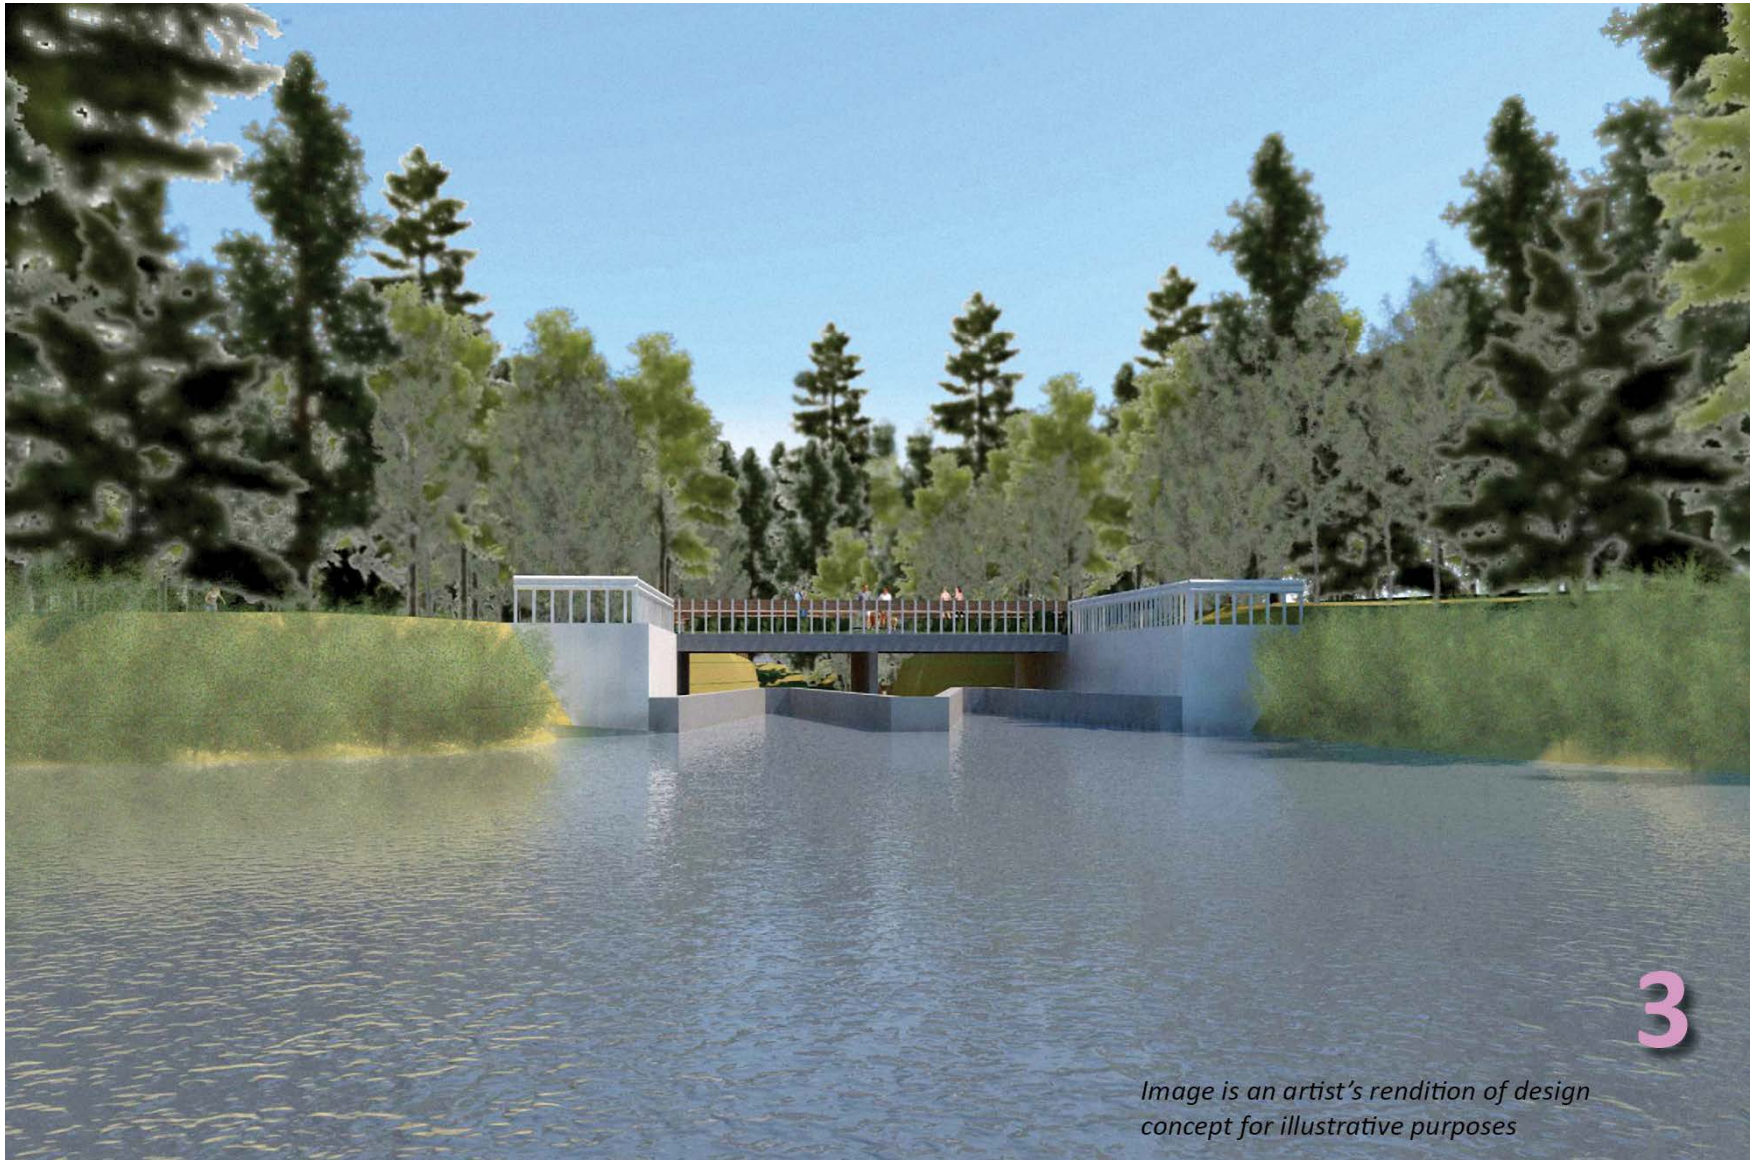
PROJECT No.	1314470516	PHASE No. 3000
	DESIGN	DC 24 June 15	SCALE: NTS REV.
	CADD	----	----
	CHECK	JG 25 June 15	Figure D-4
REVIEW	BD 03 July 15

Image is an artist's rendition of design concept for illustrative purposes

View approximately from the floating dock

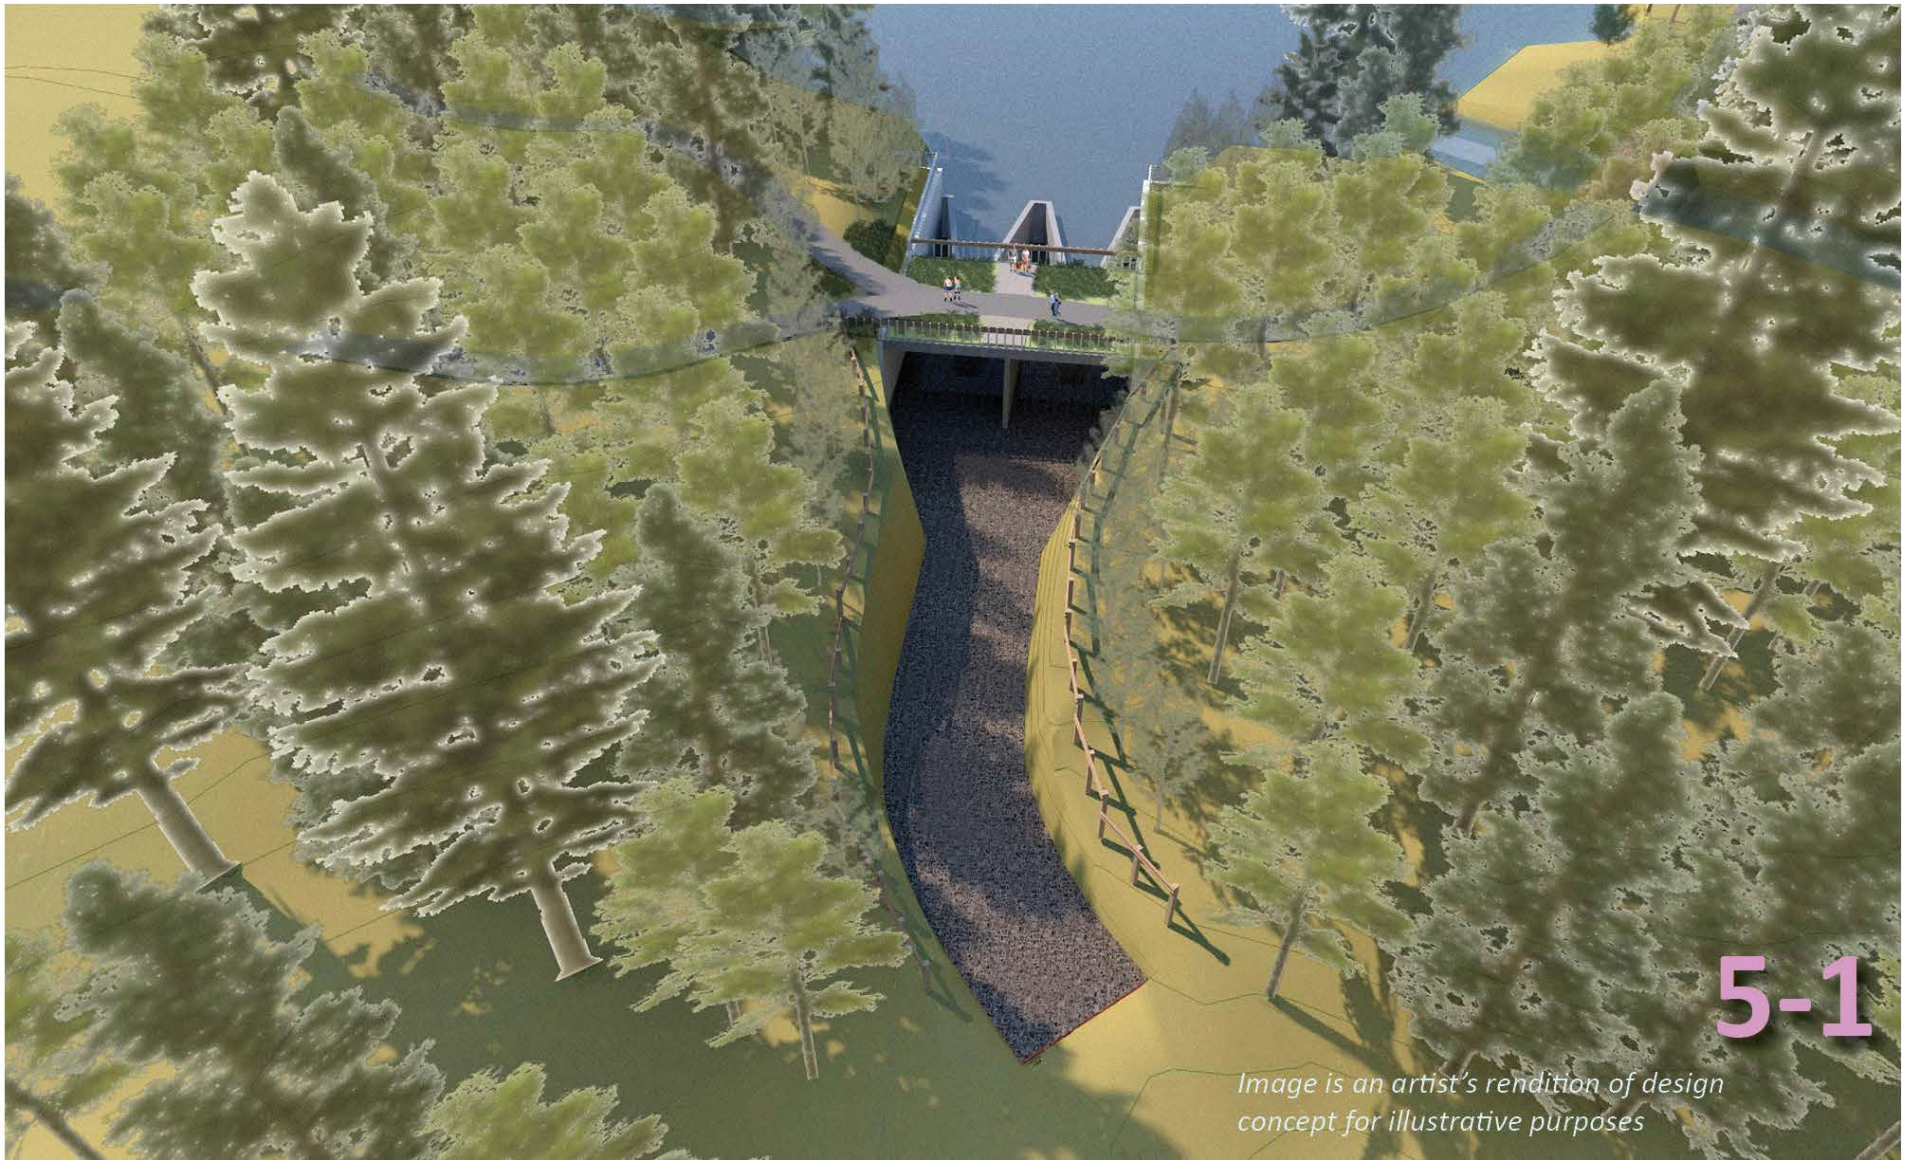
PROJECT No.	1314470516	PHASE No. 3000
	DESIGN	DC 24 June 15	SCALE: NTS REV.
	CADD	----	
	CHECK	JG 25 June 15	Figure D-6
REVIEW	BD 03 July 15

Image is an artist's rendition of design concept for illustrative purposes

Areal view from the south
